EARTHQUAKE INDUCED FISSURING IN BANKS
PENINSULA LOESSIAL SOILS: A GEOTECHNICAL
INVESTIGATION OF THE RAMAHANA ROAD FISSURE
TRACE

A thesis submitted in partial fulfilment
of the requirements for the Degree of
Master of Science in Engineering Geology
In the Department of Geological Sciences
University of Canterbury

Christopher Stuart White

2016

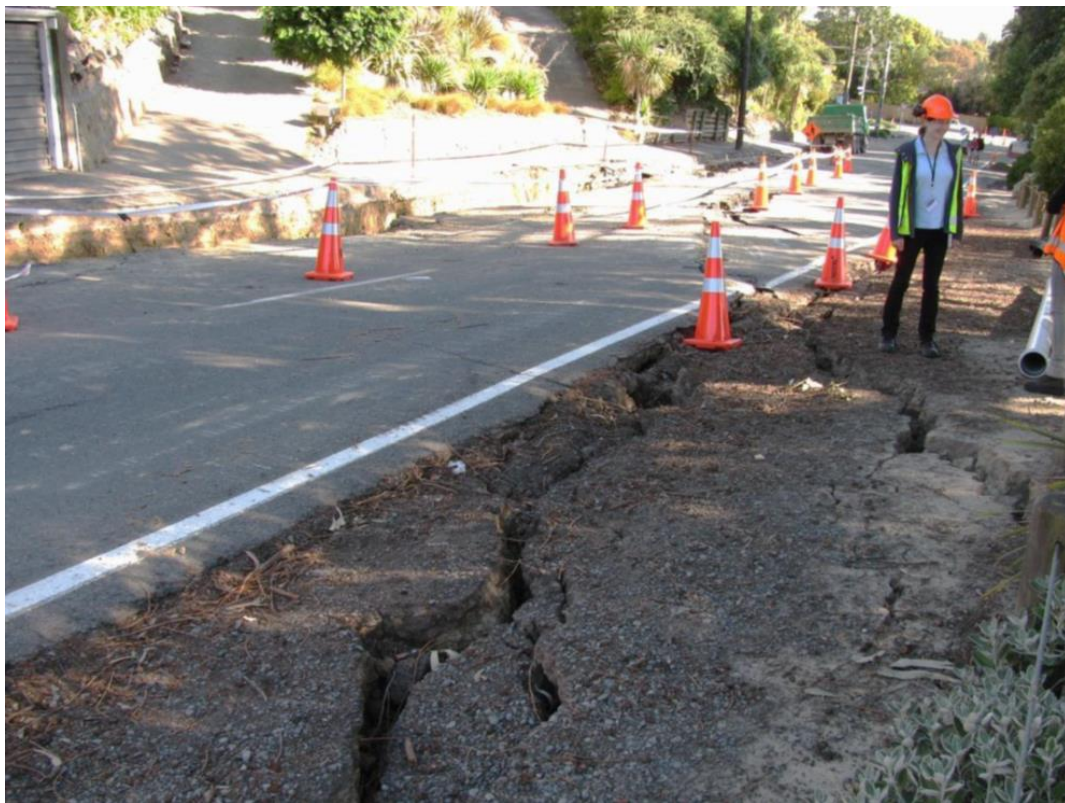
Figure 1.1: Fissure traces running through Ramahana Road. Photo looking North towards Centaurus Road. Photo after Stephen-Brownie (2012).

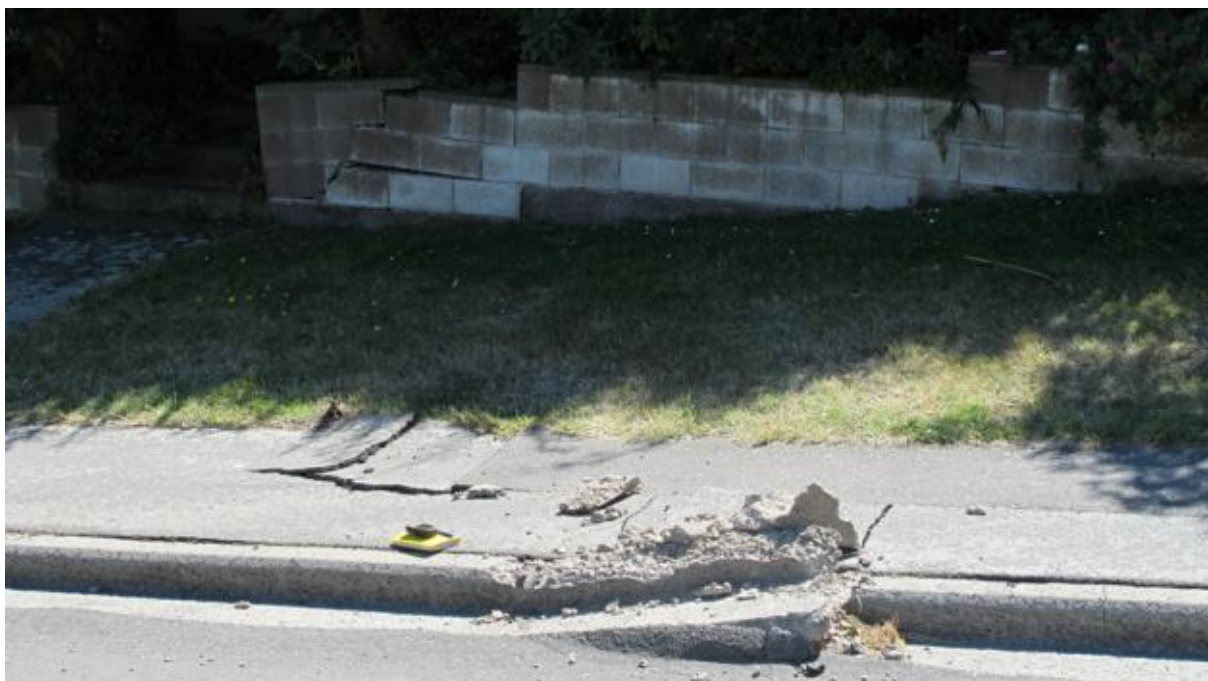
Figure 1.11: Buckling in a curb in the compressional zone downslope of Vernon Terrace. Photo from Dellow et al. (2011).

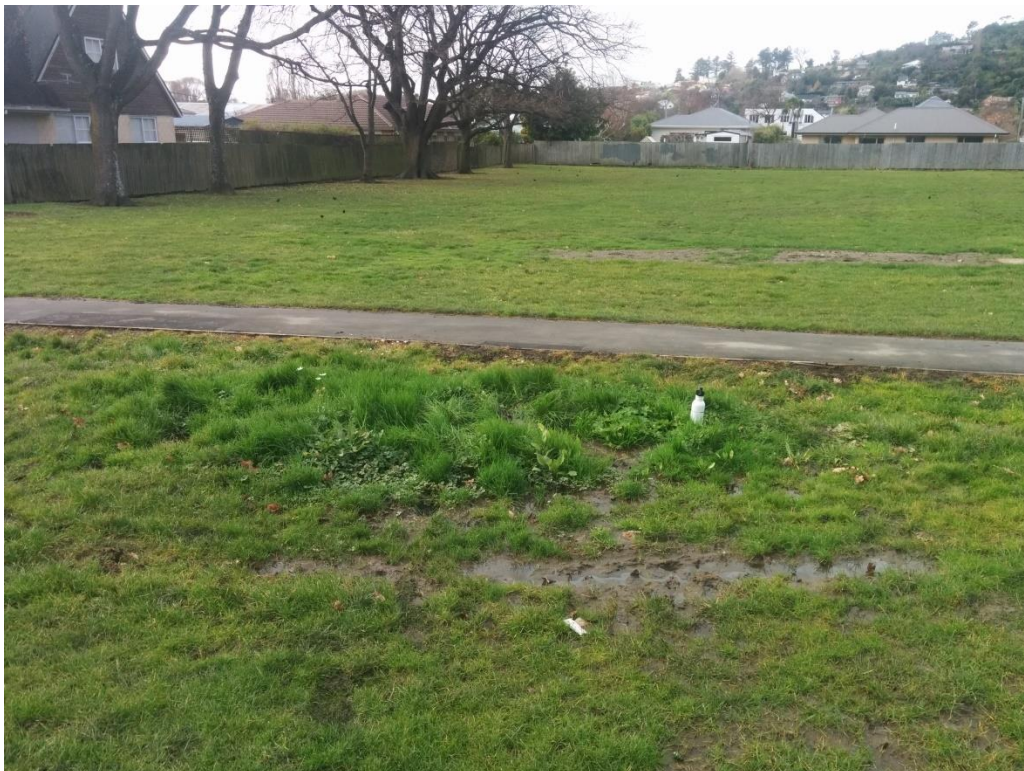
Figure 1.13: A spring within the compressional zone of Centaurus Park as of the 4th of August 2015. The water bottle is 30cm to the right of where the spring is seeping water to the ground surface. Around the seepage point there is stagnant water and a build-up of loose mud up to 5cm deep. The longer grass indicates the area affected by the spring.

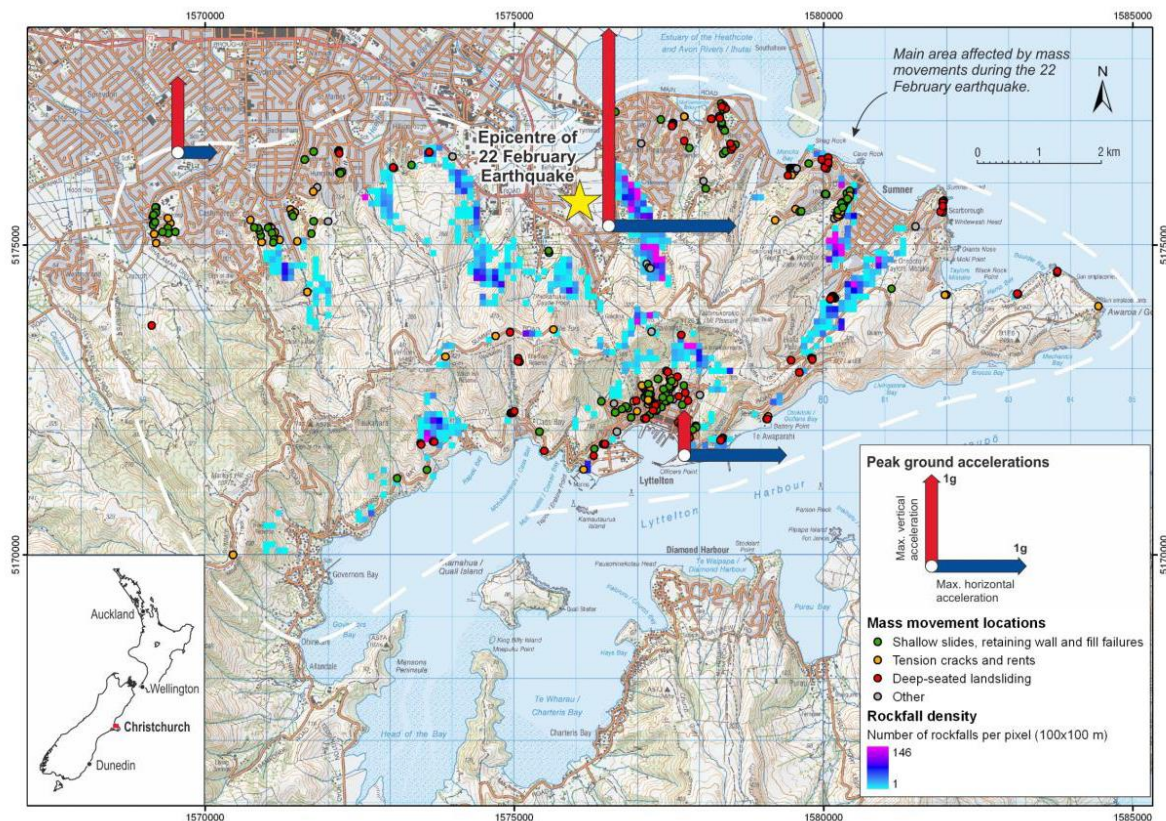
Figure 2.18: Landslide damage in the Port Hills caused by the Christchurch Earthquake. From Dellow et al. (2011).

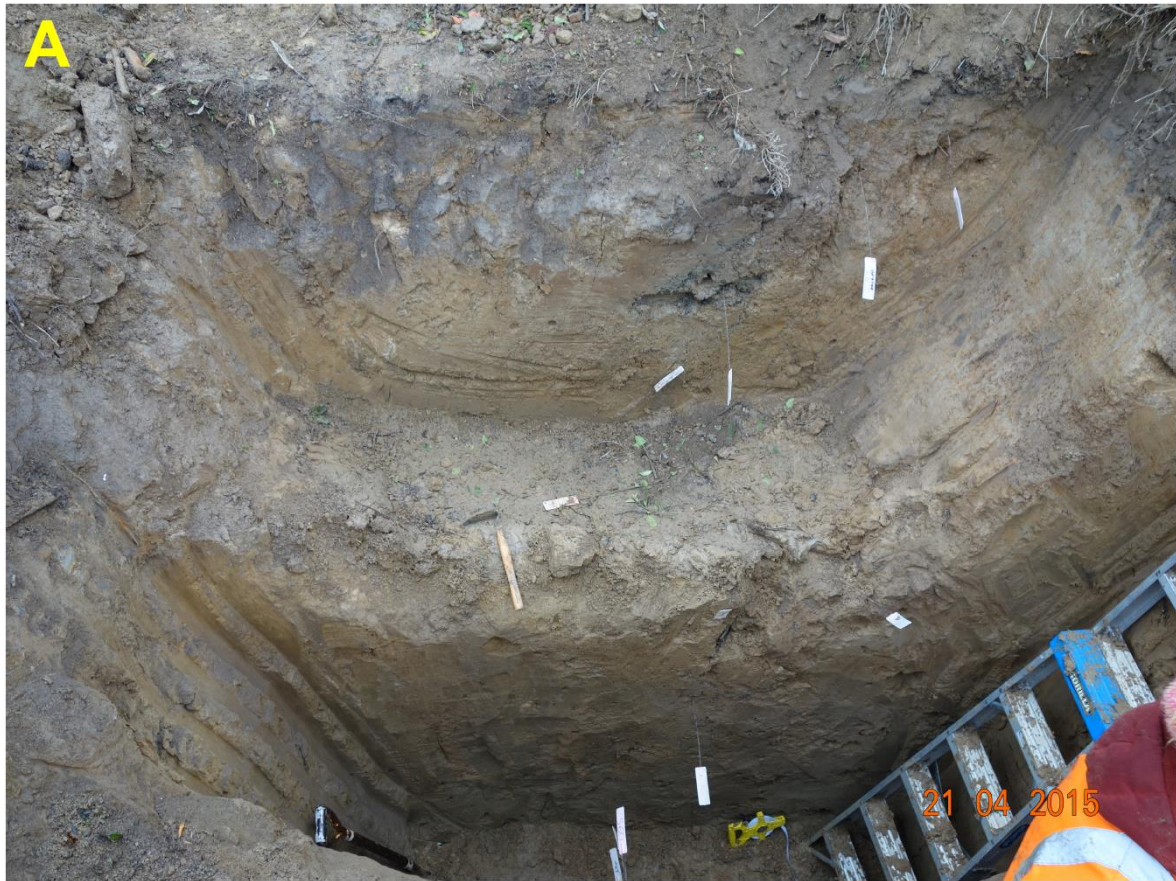
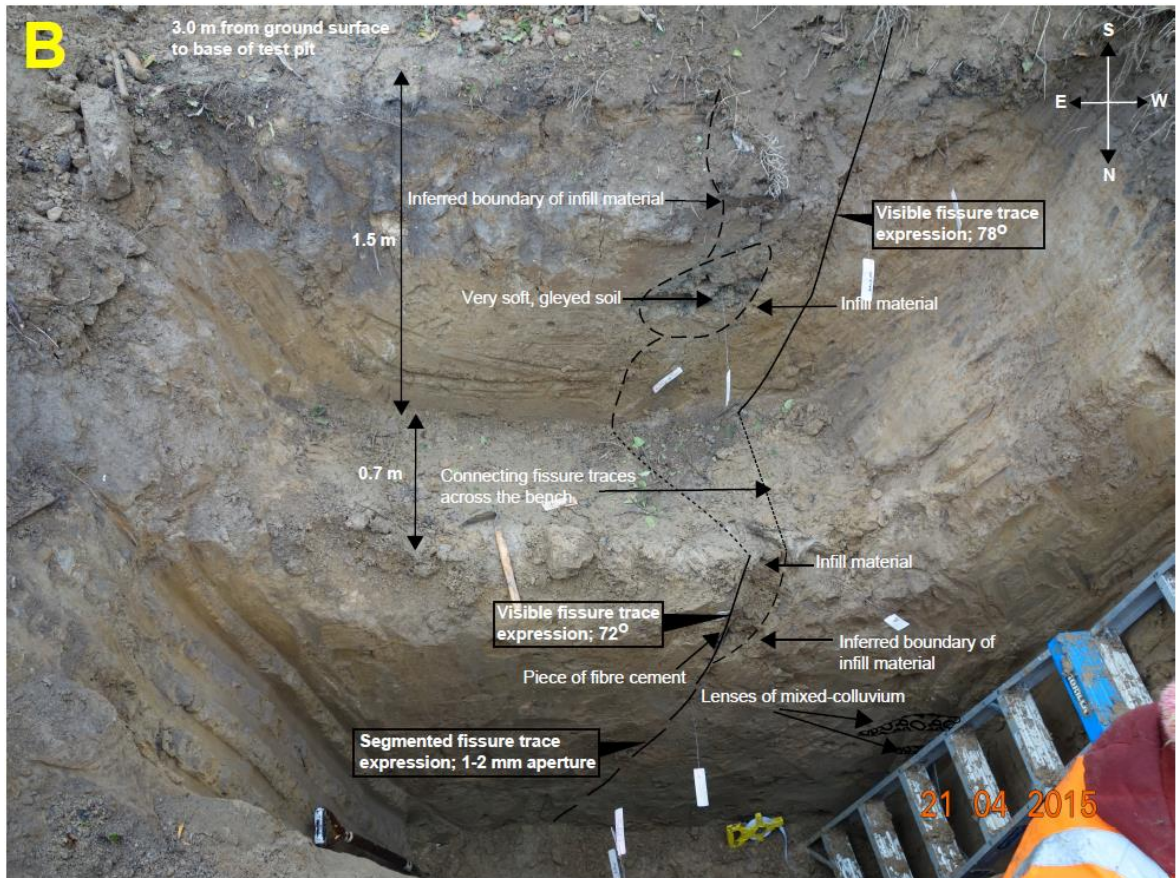
Figure 3.6: Photo of the south wall of the test pit perpendicular to the fissure trace at 17 Ramahana Road. A is without interpretation, B is with interpretation of fissure trace features.

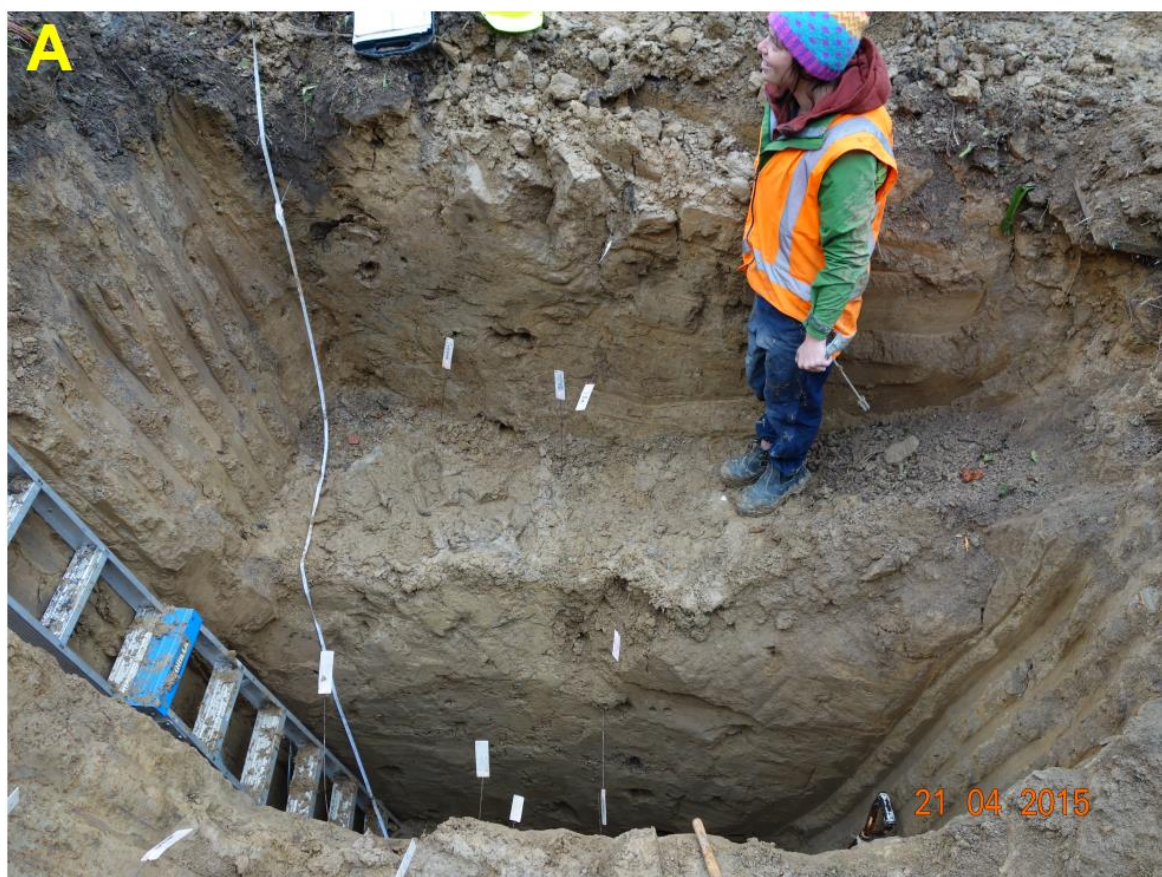
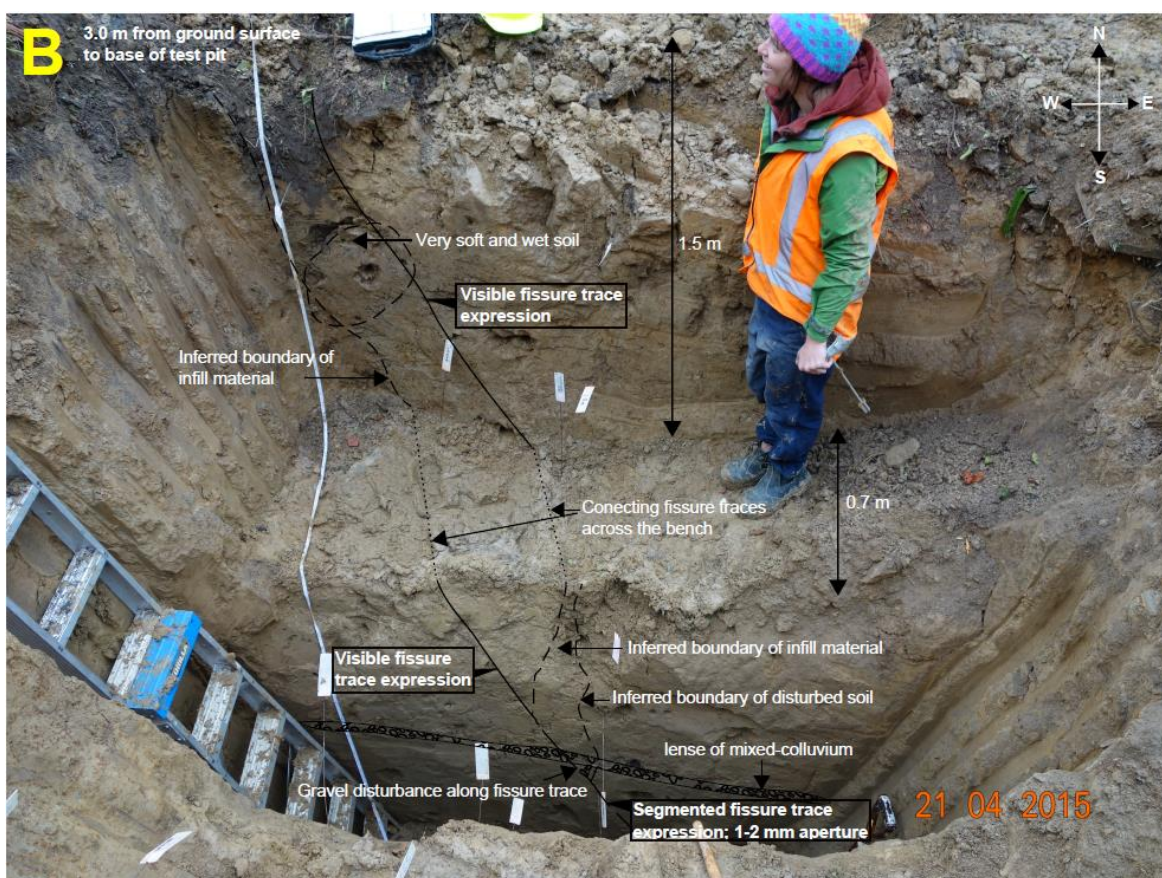
Figure 3.7: Photo of the north wall of the test pit perpendicular to the fissure trace at 17 Ramahana Road. A is without interpretation, B is with interpretation of fissure trace features.

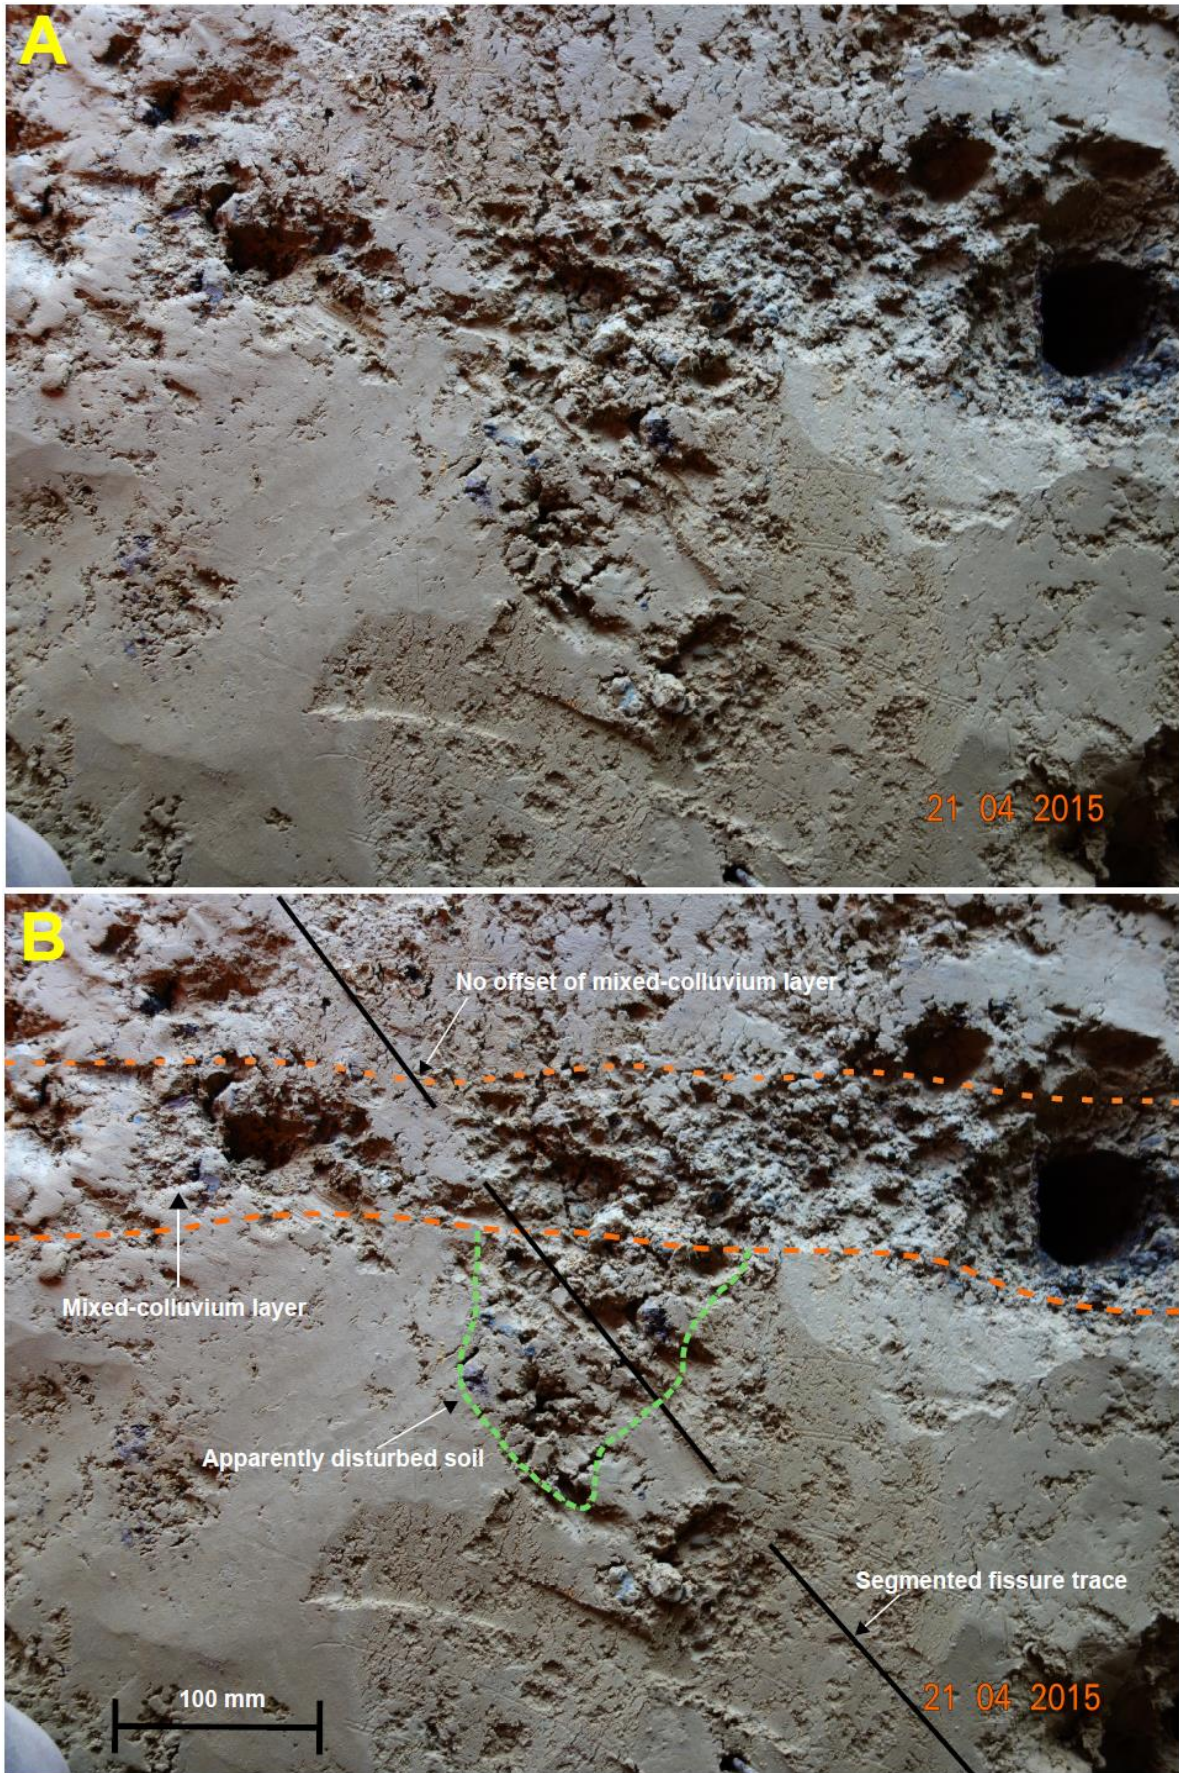
Figure 3.8: Photo of mixed-colluvium layer with fissure trace running through it on the north wall of the test pit. A is without interpretation, and B is with interpretation of fissure trace features.

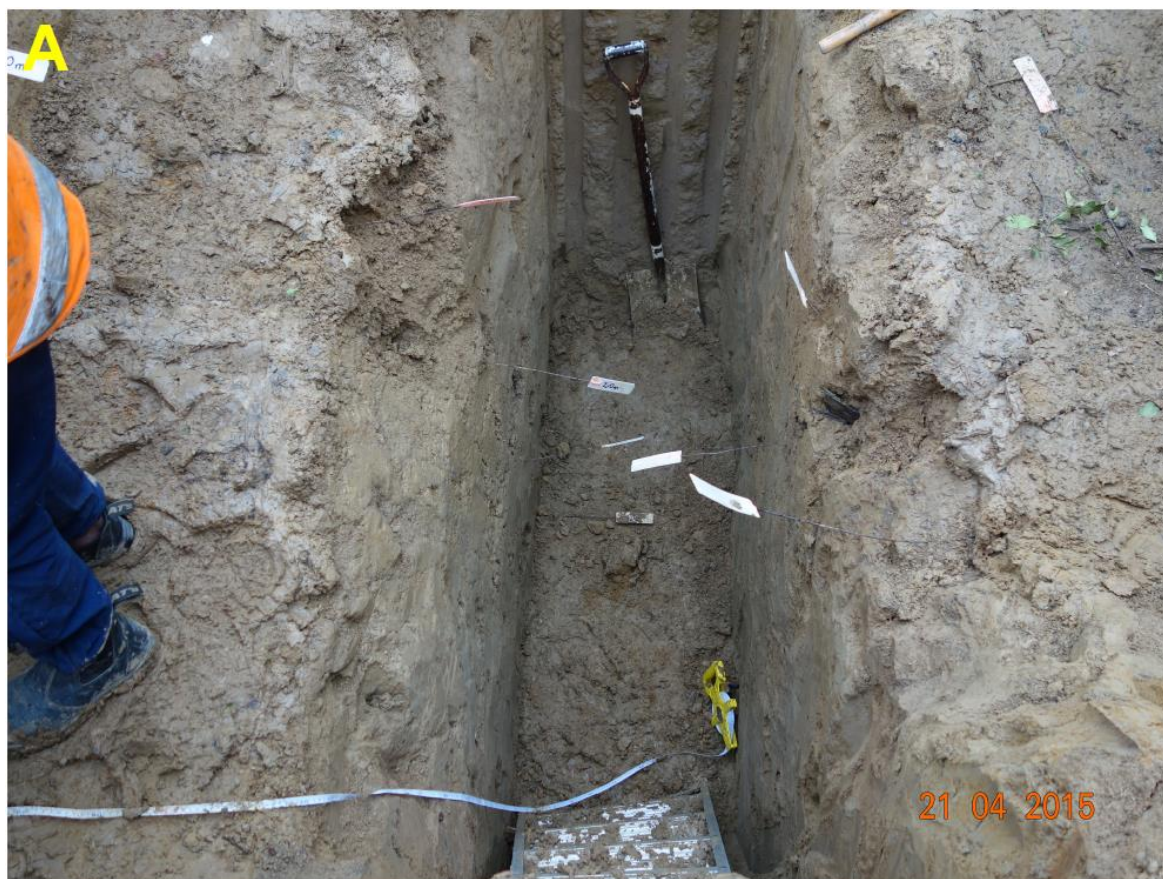
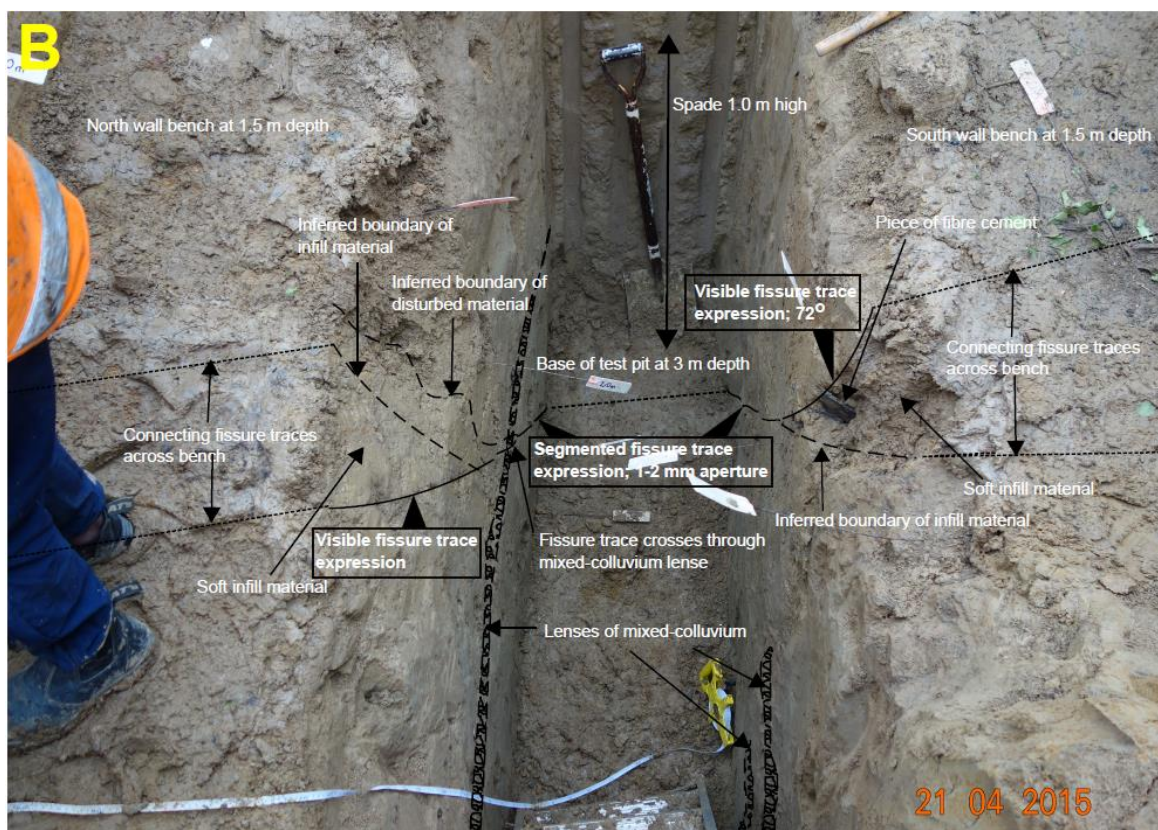
Figure 3.9: Photo of test pit through fissure trace at 17 Ramahana Road looking down into test pit from the western side. A is without interpretation, and B is with interpretation of fissure trace features.

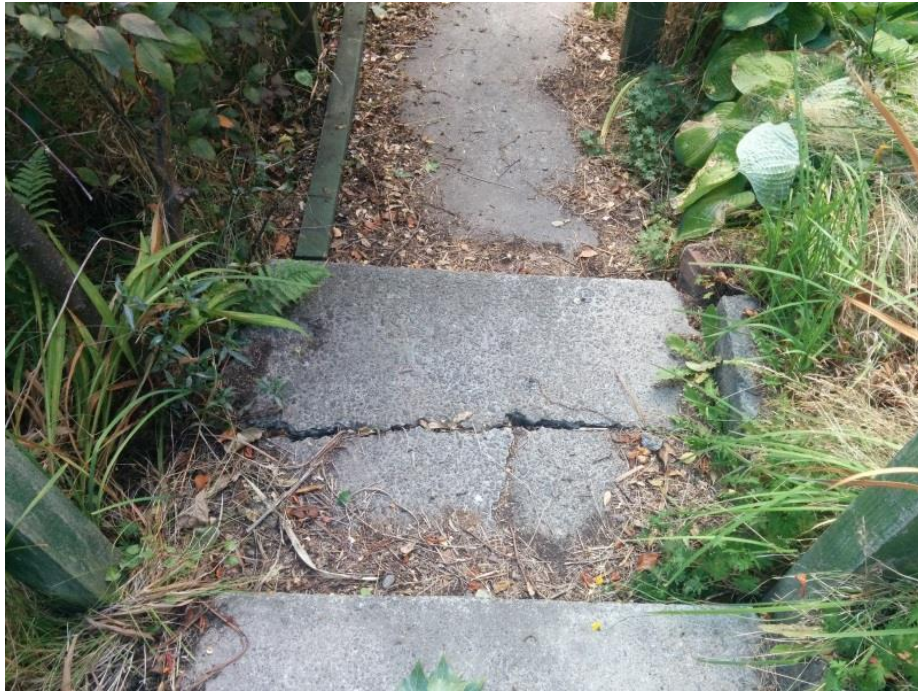
2.2.4: The tilted garden retaining wall in the compressional zone adjacent to the cracked step.
